# Manhole Inspection Summary

Manhole # S45C2\_031MH

Insp Date: **12/21/07 10:25 AM**

**Location** Address: **Sassafras St.**

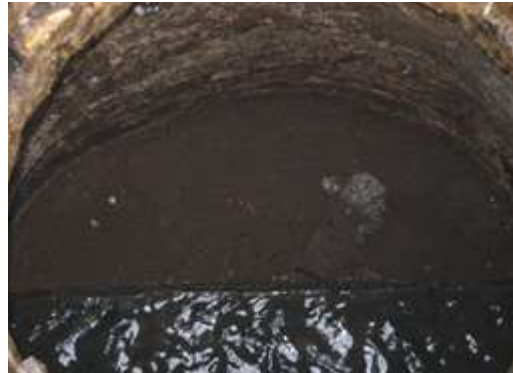
Defect 2

Debris

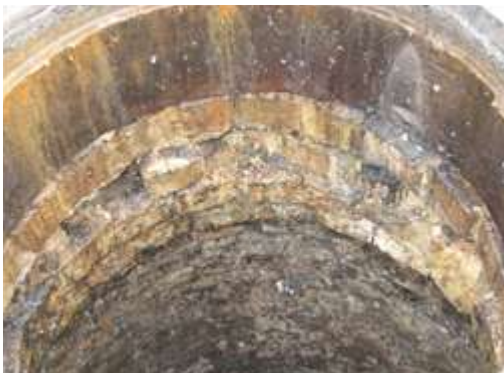
Defect 1

Condition: ☐ Sound ☐ Cracked ☐ Root Intrusion ☒ **Loose Brick** ☐ Deteriorated

Infiltration: ☐ None ☒ **Joint** ☐ Cracks ☐ Mortar ☐ Roots ☐ Wall

Loose bricks

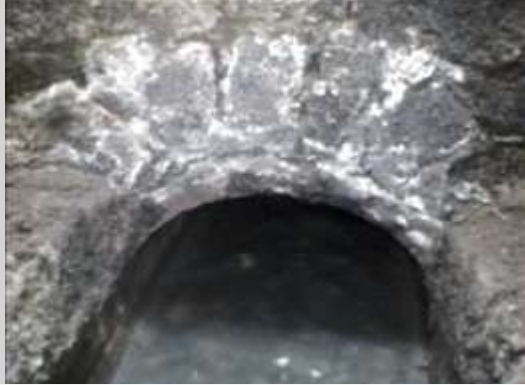
12 O'Clock Outflow

12 in. Circular Gravity Sewer  
Pipe Out @ 12 O'Clock

Pipe Height: **12** (in.) Rod and Bar (Angled)  
Pipe Material: **Clay** ☐ Pipe Lined  
Invert Depth: **7.67** (ft.) Flow Characteristics: **Slow**  
Deposits: ☒ None ☐ Mud ☐ Sludge ☐ Debris ☐ Grease  
Silt Depth: (in.) Deposits Extent:  
Infiltration: **None** Pipe Seal Cond: **Sound**

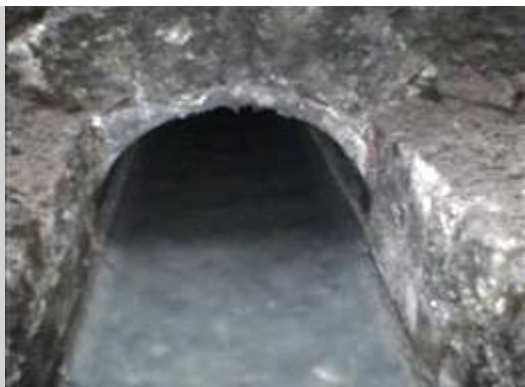
6 O'Clock Inflow

12 in. Circular Gravity Sewer  
Pipe In @ 6 O'Clock

Pipe Height: **12** (in.) Rod and Bar (Angled)  
Pipe Material: **Clay** ☐ Pipe Lined  
Invert Depth: **7.78** (ft.) Flow Characteristics: **Slow**  
Deposits: ☒ None ☐ Mud ☐ Sludge ☐ Debris ☐ Grease  
Silt Depth: (in.) Deposits Extent:  
Infiltration: **None** Pipe Seal Cond: **Sound**
